Determining Root Causes of Mysterious Hardware Failures using High Resolution CT Scanning

Michael R. Johnson

Jet Propulsion Laboratory

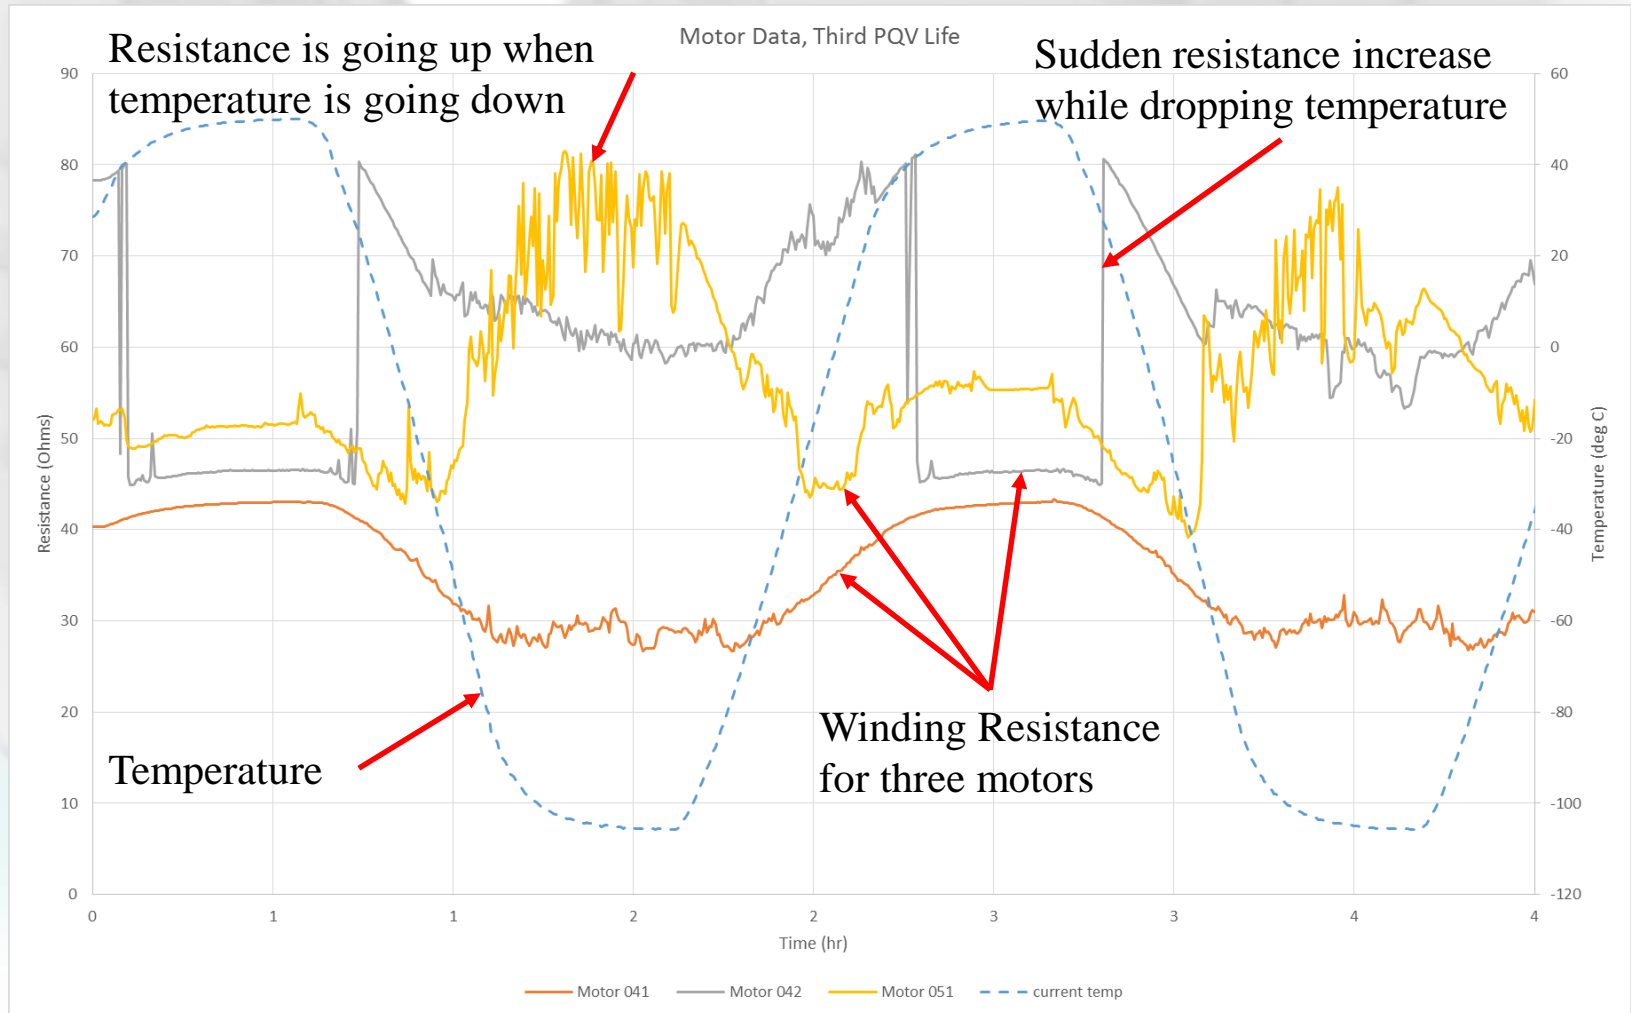
- The test started well, but then . . .

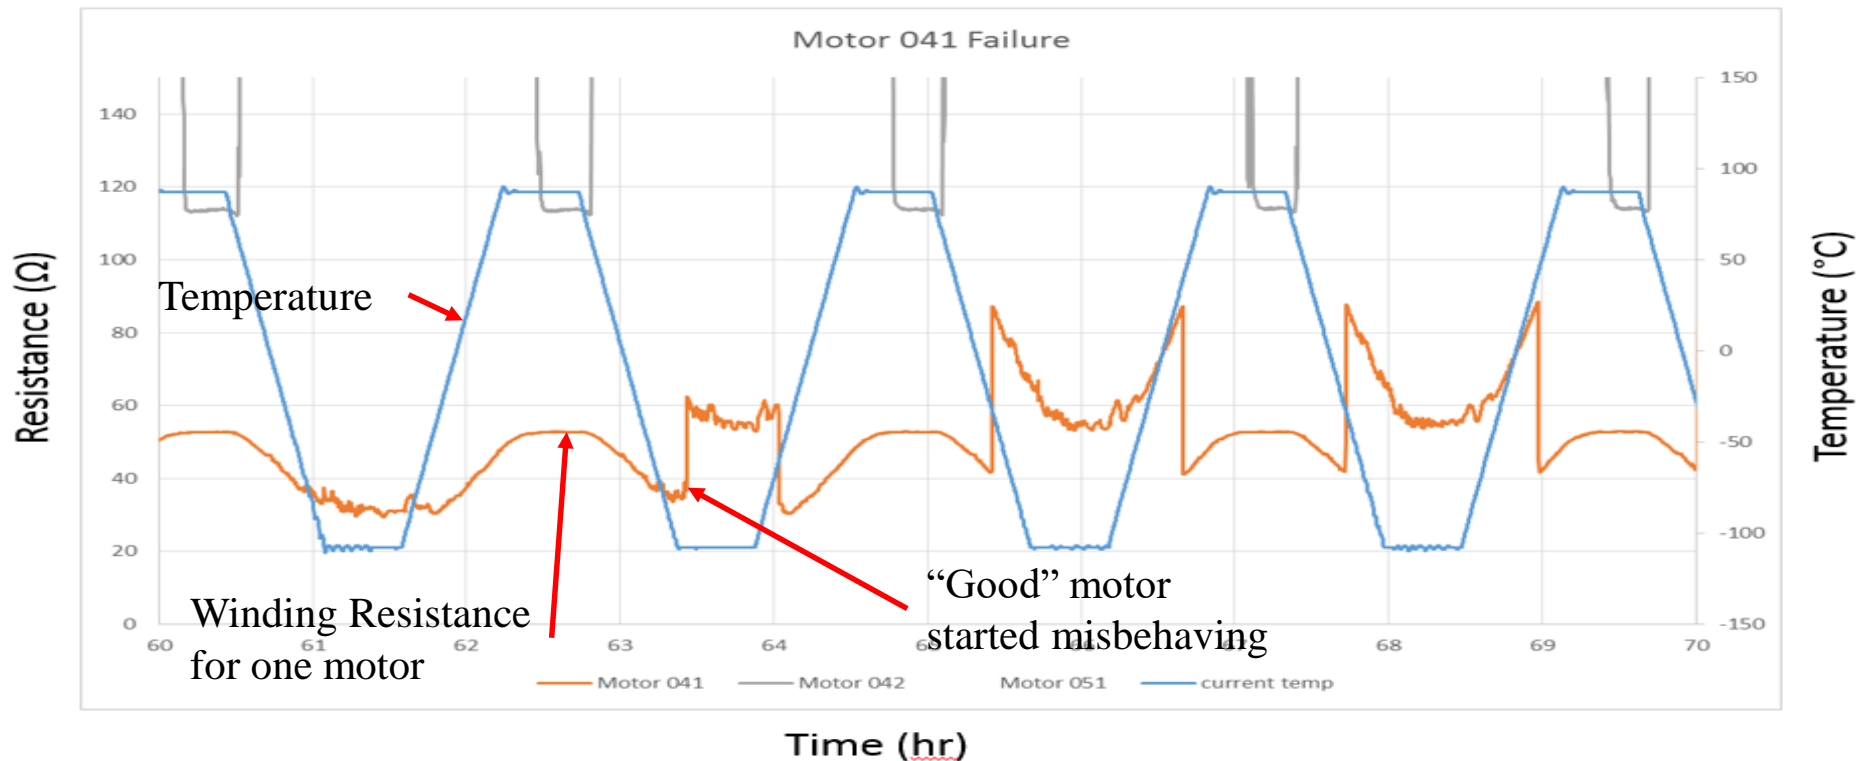
- It appeared that one motor was behaving, until . . .

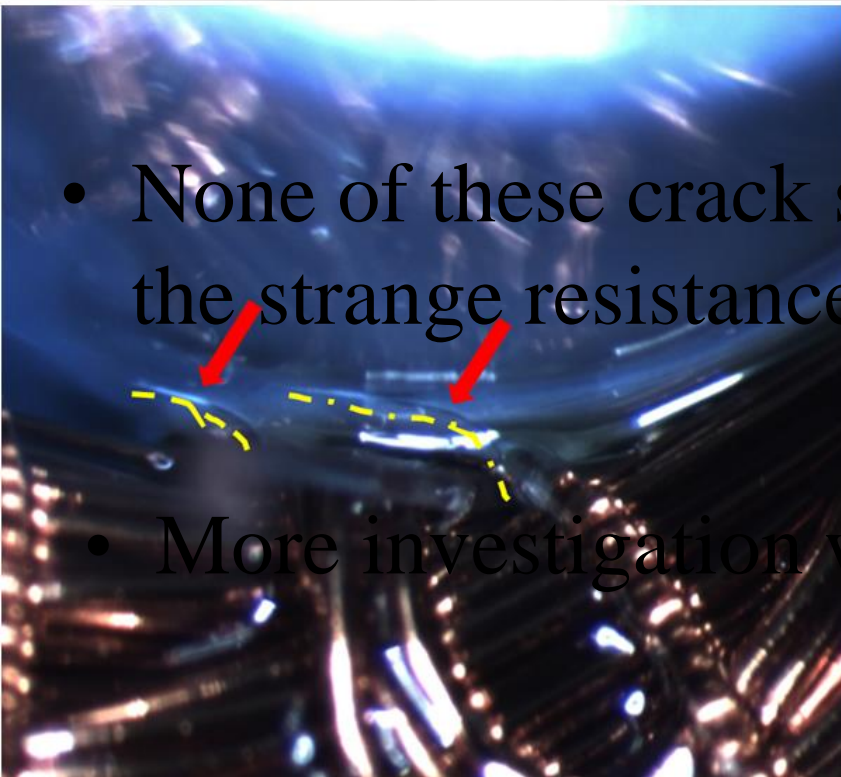
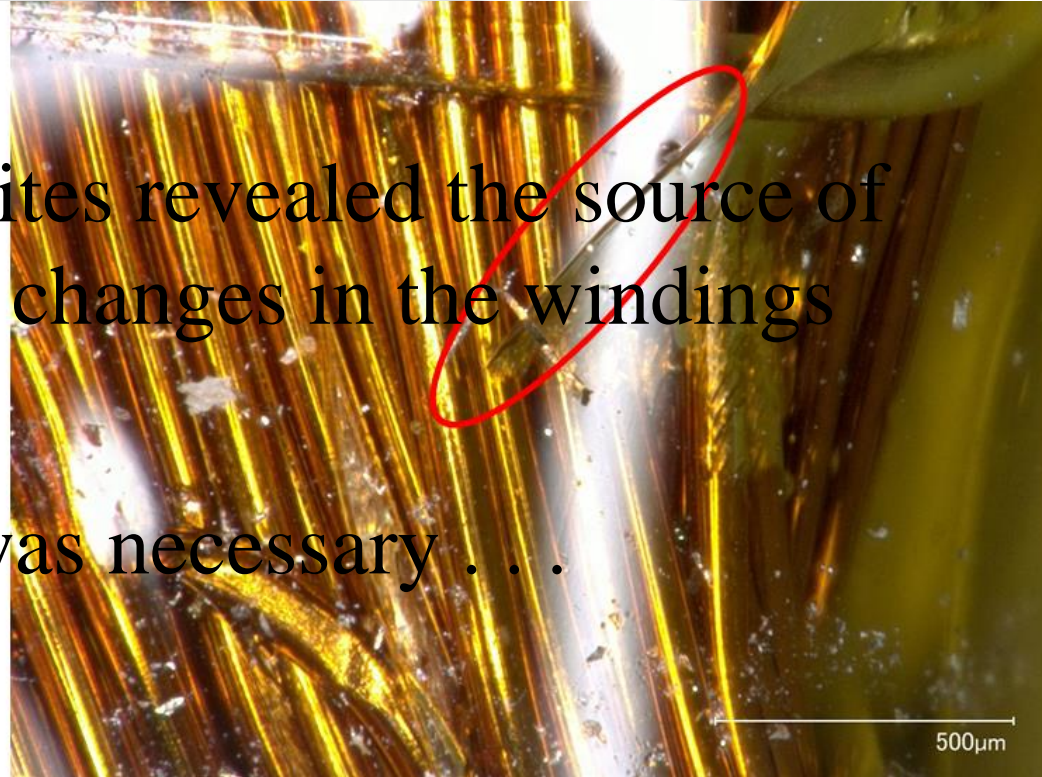
- Inspection of the three motors with an optical microscope revealed the presence of cracks in the epoxy restraining the motor windings

- None of these crack sites revealed the source of the strange resistance changes in the windings

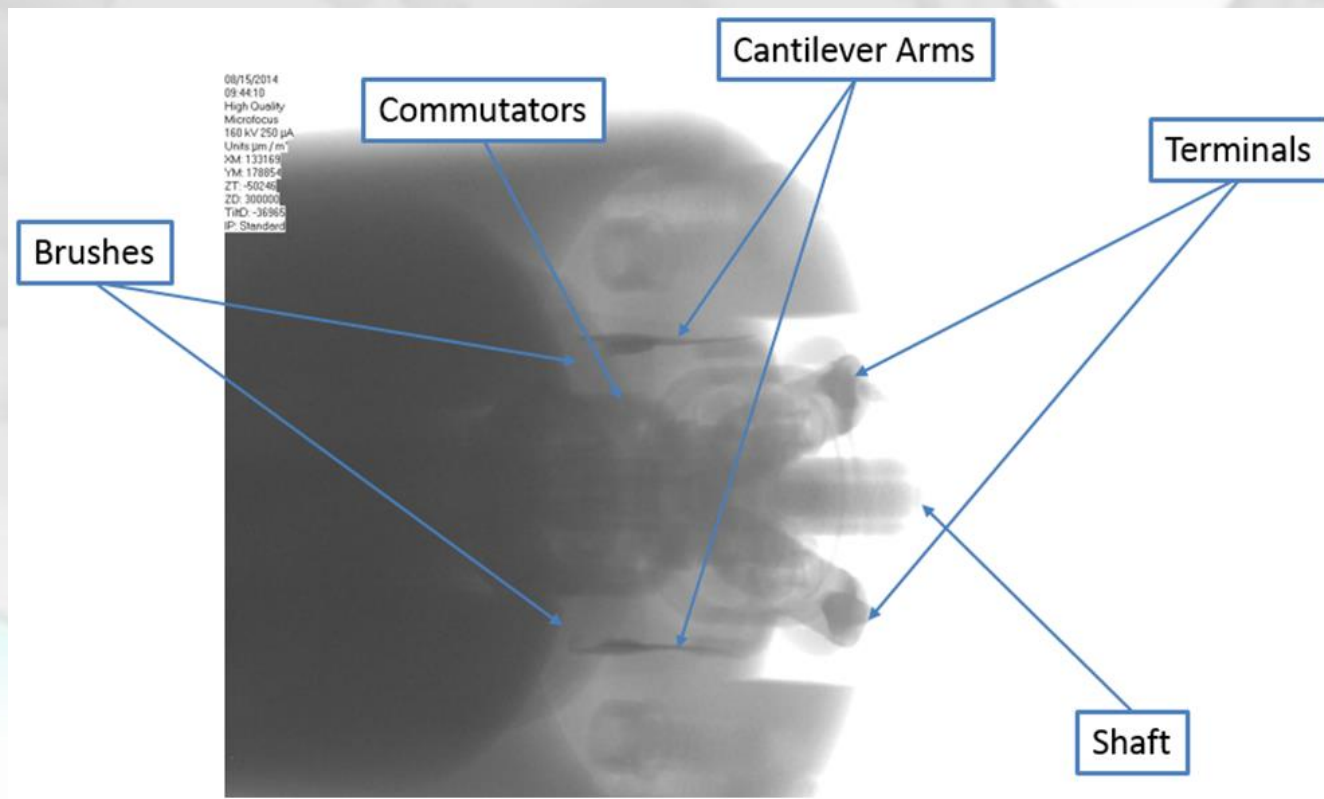
- Standard X-ray inspection revealed nothing useful
- The brushes can be seen to be properly assembled!

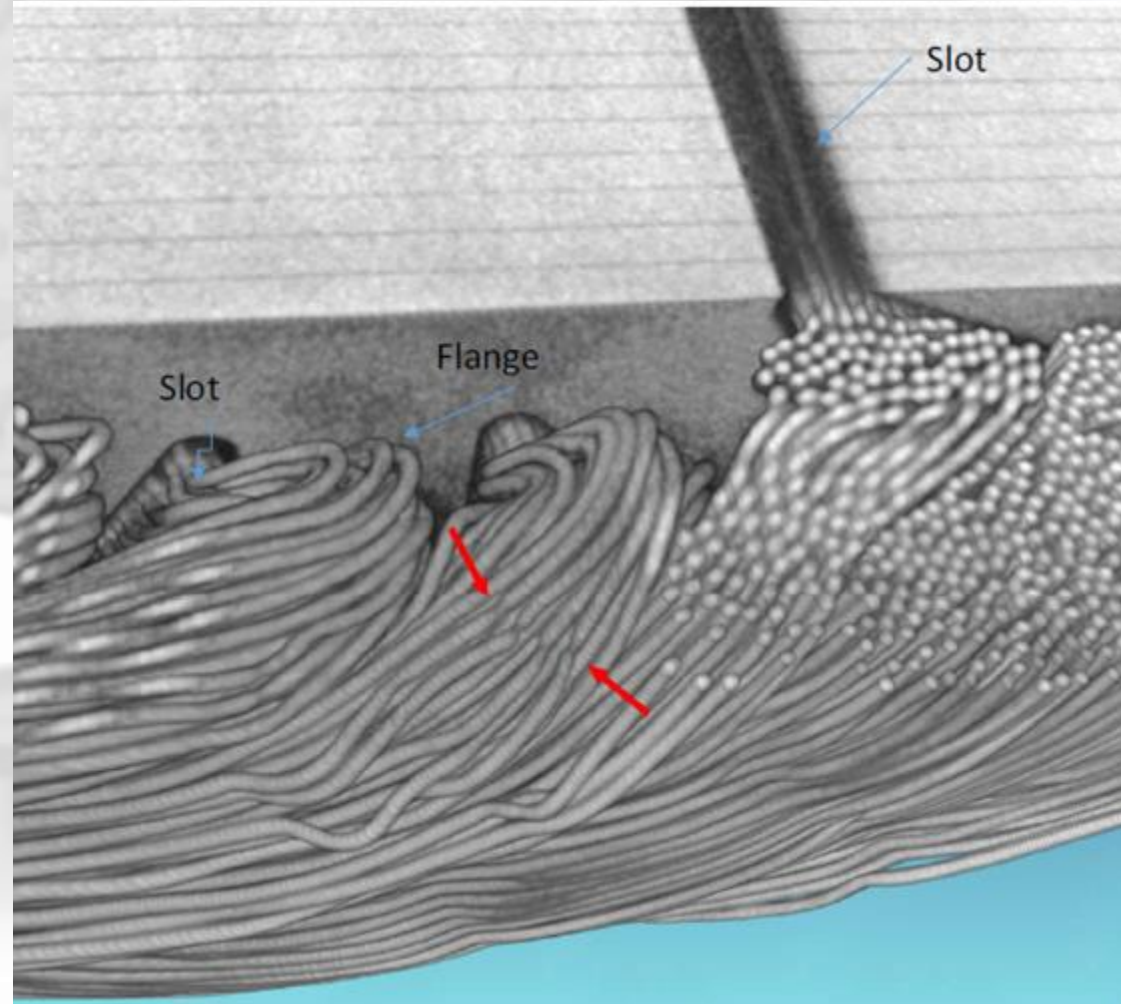
- The CT scanned model provides the opportunity to investigate the individual wires within the winding assembly
- The model allowed zooming into the areas where the cracks in the epoxy were identified in the optical inspection
- Wire damage seemed to be apparent at the locations of the cracks in the epoxy

- The arrows indicate possible damage to the winding wires
- The high resolution of the model allowed further magnification of these locations

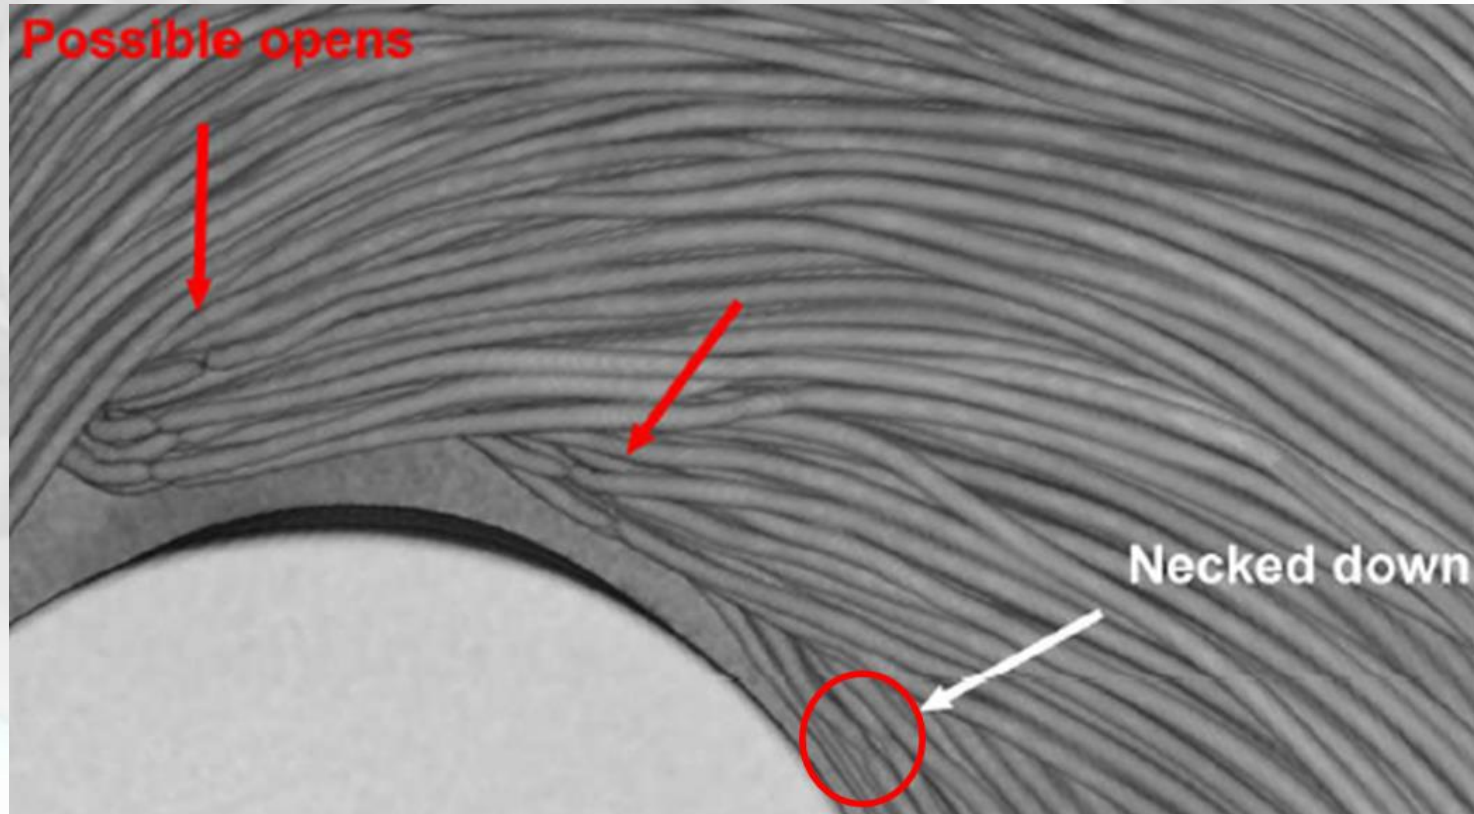
- Breaks in individual wires were detected with reduced cross-sectional area (necked down)
- Other locations showed necked down regions as well

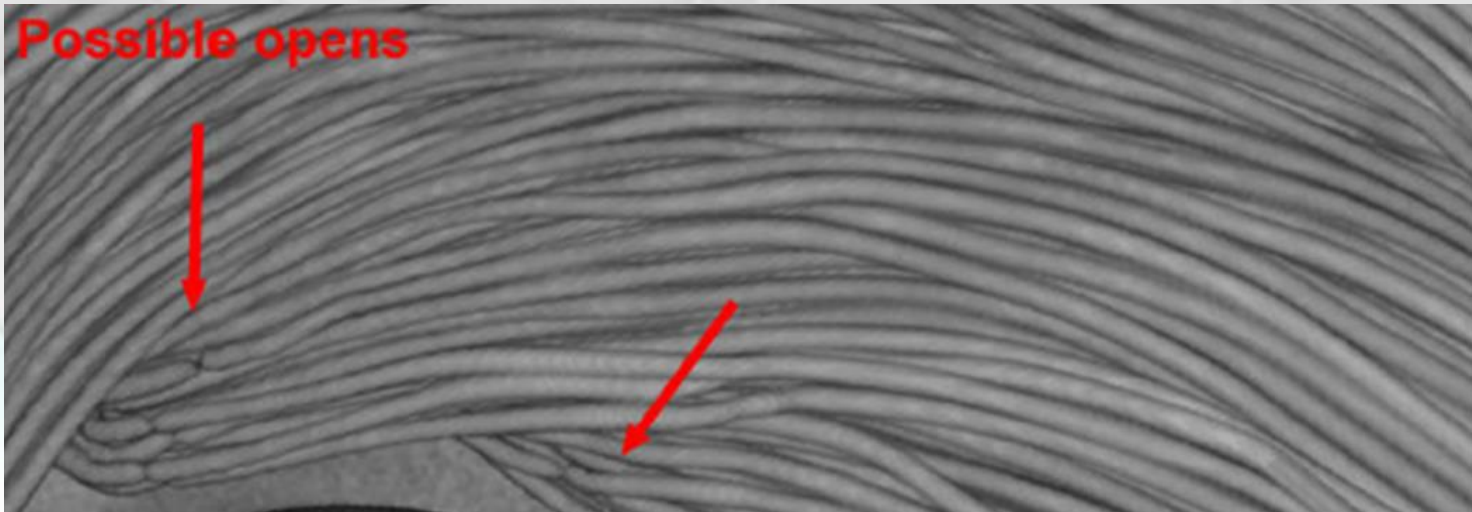
- The reduced cross-sectional area indicated a tensile failure of the wire that is temperature dependent
- The failed regions would re-contact as the temperature was raised, hiding the failure at warmer temperatures

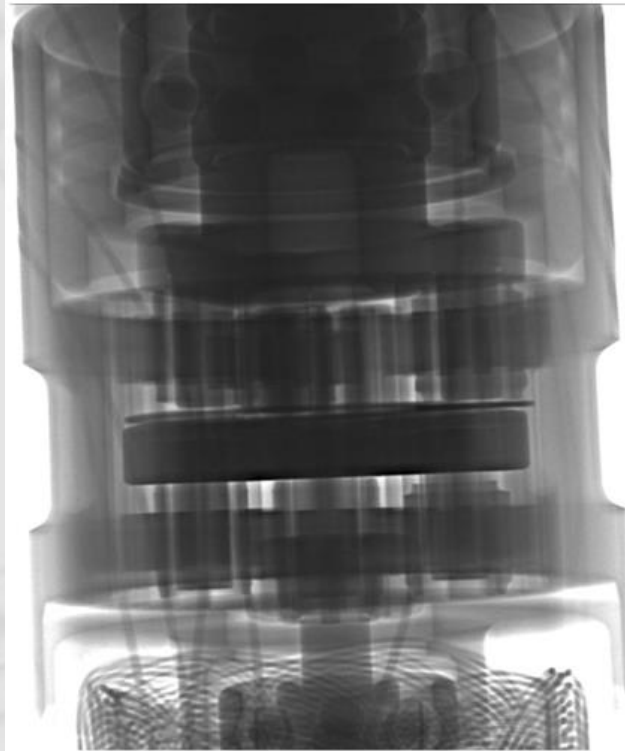
- Standard X-ray inspection seemed to indicate the rotor was displaced axially

X-Ray Image Showing the Gearbox Section of the Actuator.

Output Ball Bearings are at the Top of the Image and the Front Motor Bearing is at the Bottom

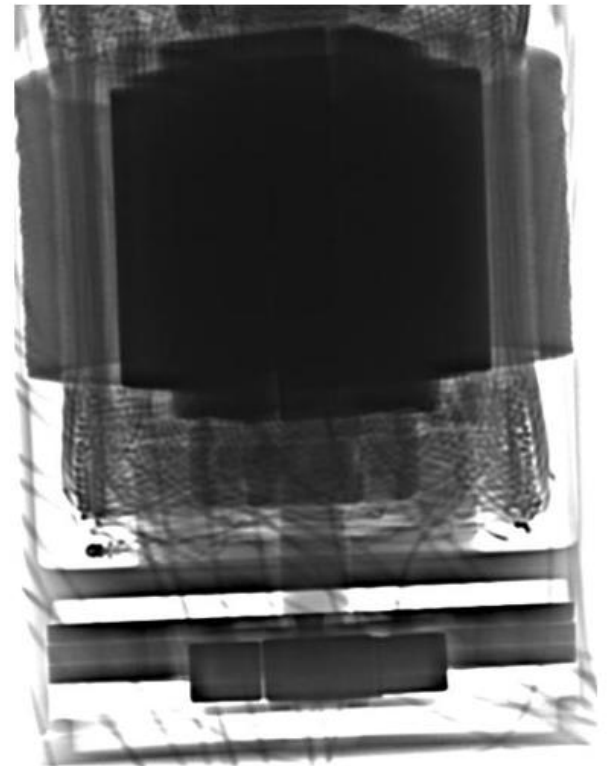
X-Ray Image Showing the Detent Magnet Section of the Motor Assembly. Magnets are on the Rotor and the Teeth are on the Stator

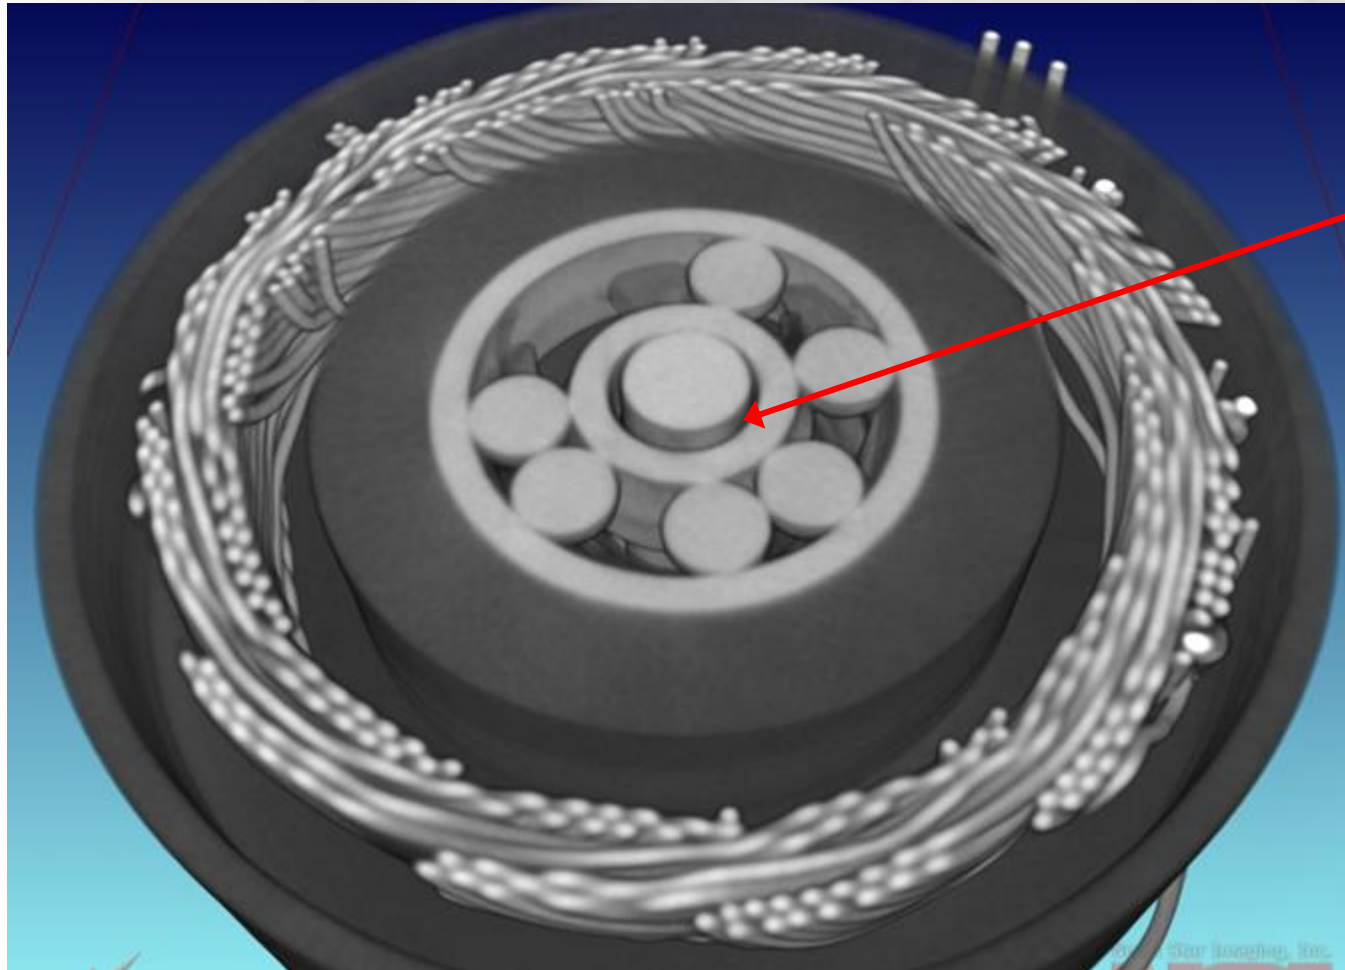
- Until the motor rear bearing was revealed!

- Notice the fit of the motor shaft to the bearing bore . . .

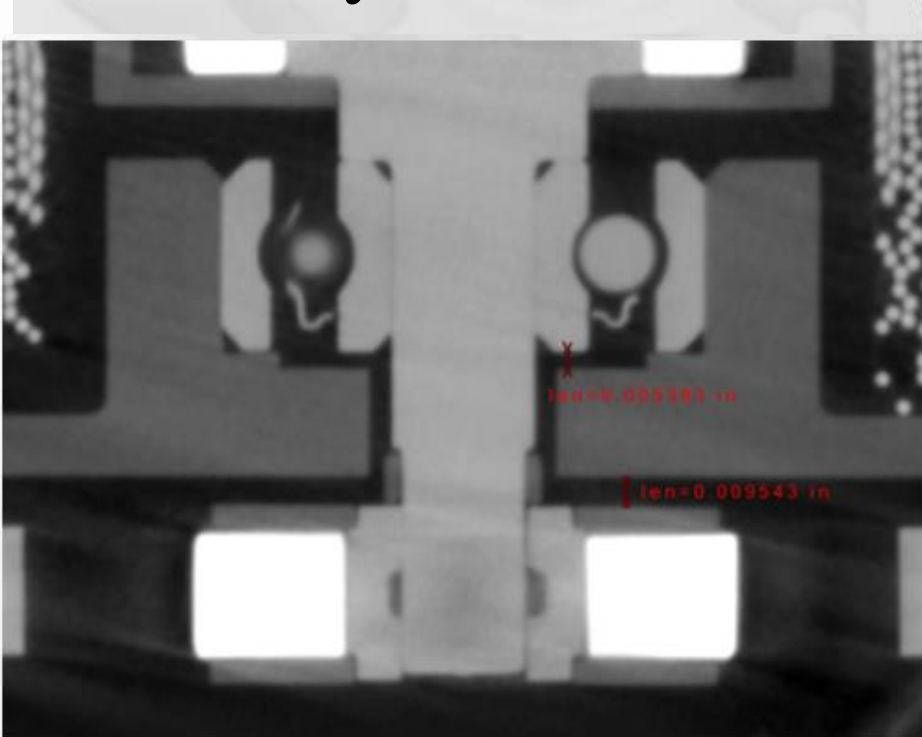
*Healthy Motor at the Beginning of Life Showing Bearing Placement and Shaft Fit.
The measurements in the images are in inches
(0.0095 in = 241 microns)*

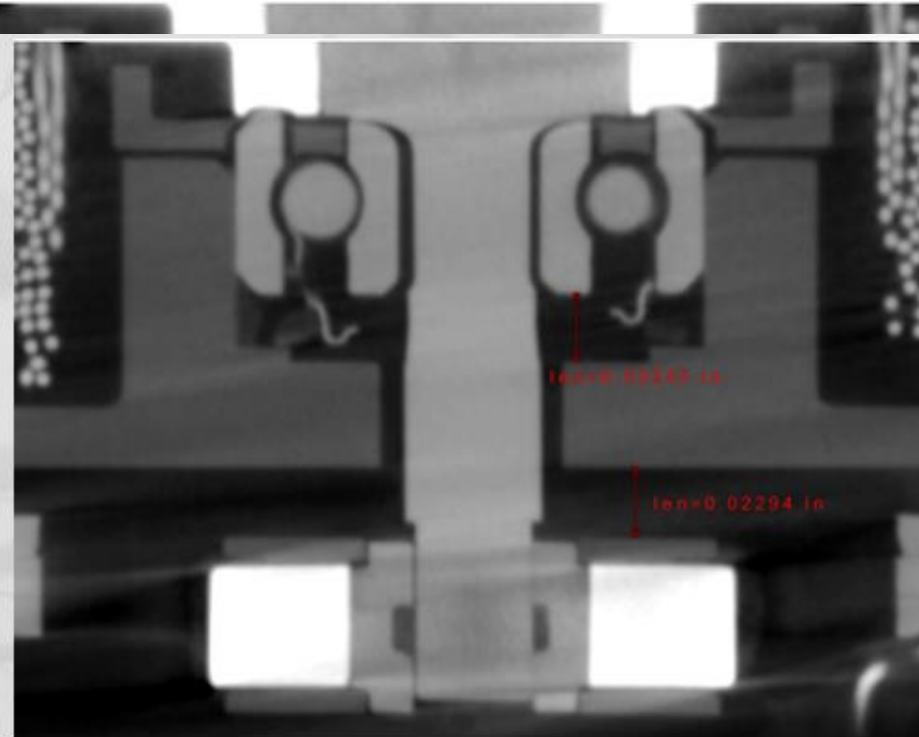
*Life Test Motor Showing Shaft Wear and the Bearing Having Moved Toward the Rotor. The Ball Retainer is Seen Located Under the Bearing Assembly.
(0.0229 in = 582 microns)*
